North Cannon River Watershed

2019 Monitoring Report

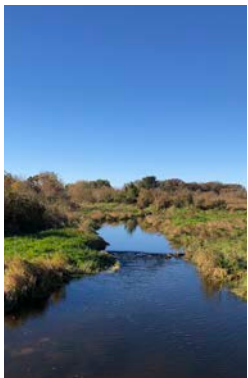
Dutch Creek is the most upstream site monitored in the watershed. At the tailend of a wetland complex, water quality data from this site show low dissolved oxygen levels, as well as *E. coli* and nitrates. Total phosphorus is highest of all monitoring sites.

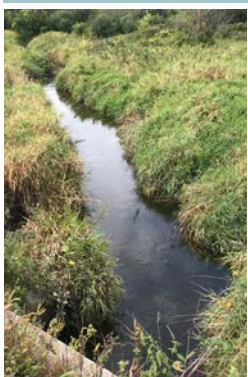
Mud Creek

Total suspended solids are low for the majority of the monitoring season, peaking in July. *E. coli* and total phosphorus levels are lowest in the spring and fall with a similar peak during the summer months. Nitrate levels fluctuated throughout the monitoring season.

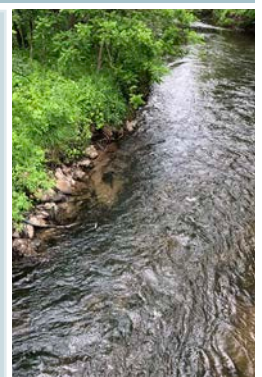
The monitoring site on Chub Creek is influenced by the three tributaries that empty into the creek further upstream. Total suspended solid levels and transparency readings are highest at this site, as sediment moves off the land and travels downstream.

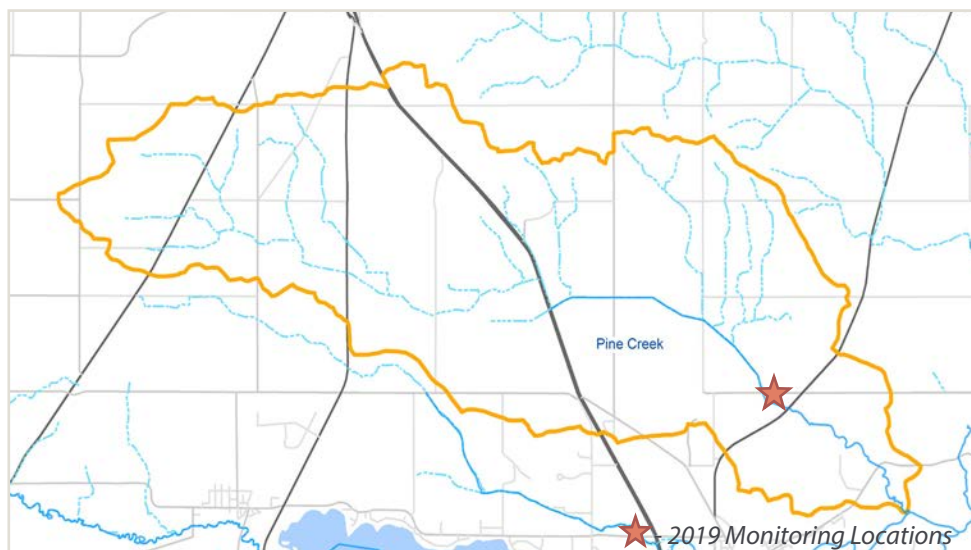
2019 Monitoring Locations

PC3 is part of the MNDNR's stream monitoring program. Water temperature and level are continuously monitored and flow measurements are collected intermittently.

MNDNR hydrologists visit this site and another site upstream intermittently to monitor streamflow from March to November each year. Continuous temperature and water level monitoring equipment are deployed at both monitoring sites year round and data is collected on 15 minute intervals. Data is available on the MNDNR's website.

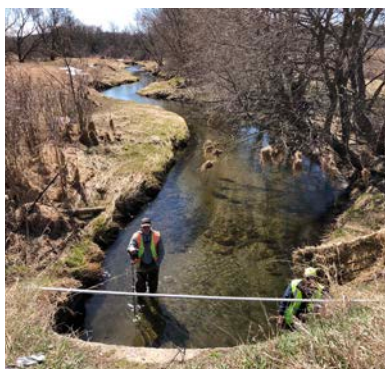
Water levels at PC2, NCRWMO historical monitoring site on Hogan Avenue

● - monitoring events by DCSWCD at PC3

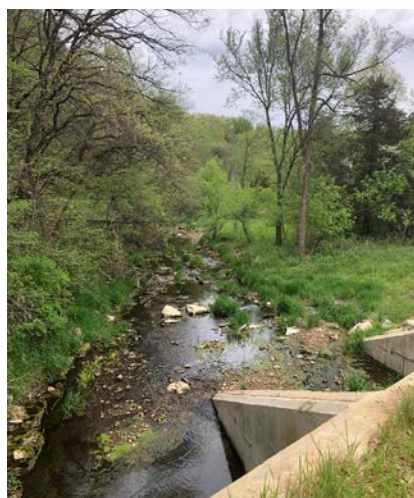
TB1 is located on the eastern tributary to Trout Brook. Dissolved oxygen levels were lower here than at other sites, but remained well above the standard all season. *E. coli* levels were higher than at other sites, with highest readings collected in late summer.

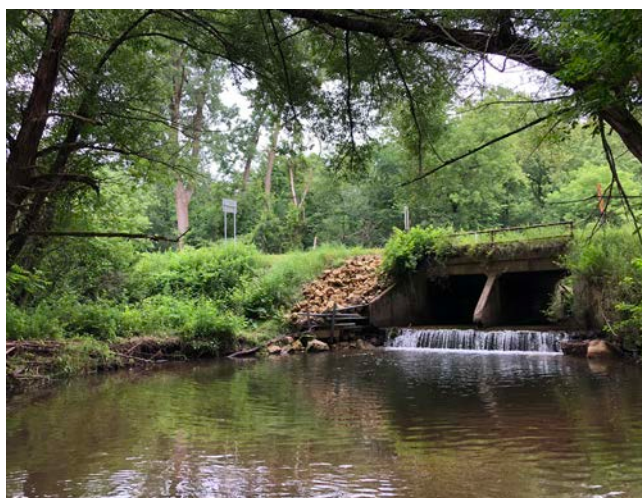
TB2 has the highest nitrate levels in the watershed. Nitrate levels are 2x higher than the state drinking water standard for the majority of the monitoring season. Fox Spring is upstream from this site and its high nitrate levels influence readings at TB2.

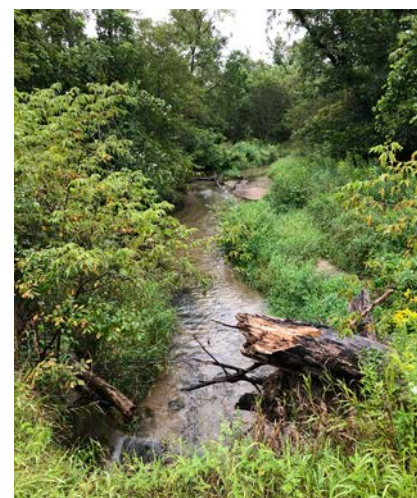
TB3 is located at the bottom of the watershed, upstream of the confluence with the Cannon River. Nitrate levels are much lower than samples from TB2, due to dilution from the eastern branch. Phosphorus and suspended solid levels are very low all season.

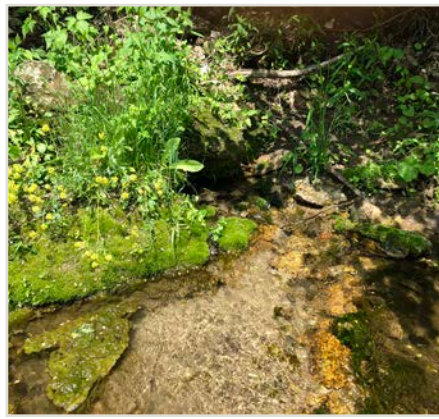
Fox Spring is the most upstream of the sentinel springs, located just east of the Miesville Ravine Park boundary. Nitrate levels are highest at this spring of all of the monitoring sites and are increasing at the fastest rate.

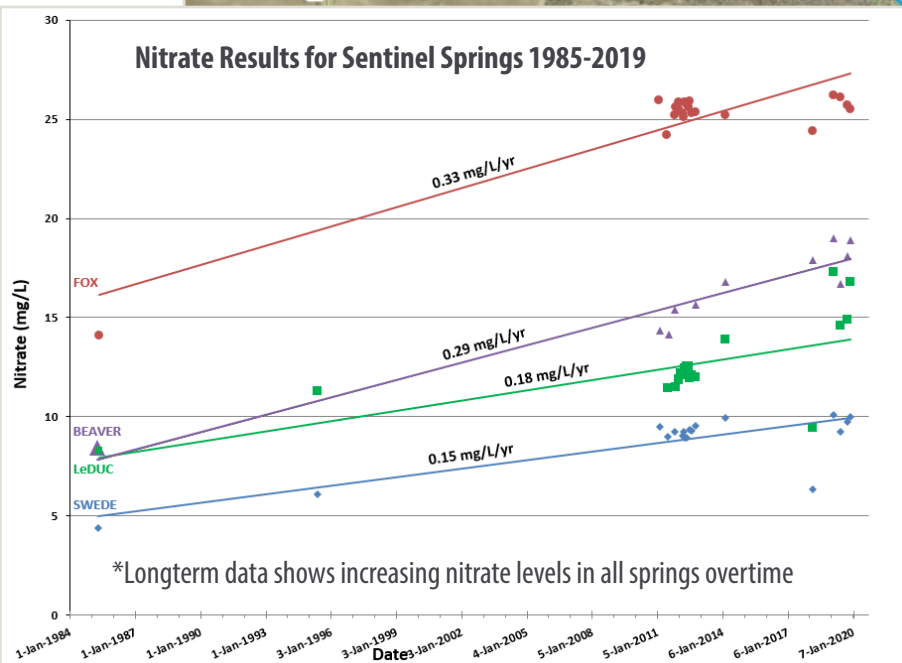
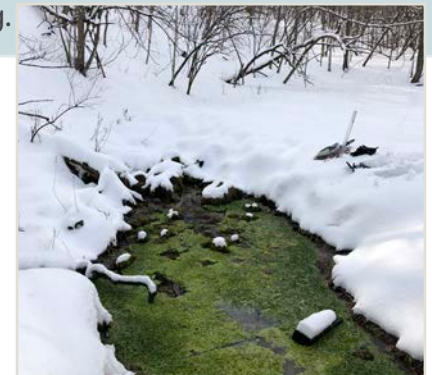
Beaver Spring is located deep within the park, hidden along a rock outcropping in the side of the bluff. Nitrate levels are increasing at the second fastest rate following Fox Spring.

Swede Spring is the southern most spring, located in the southern portion of Miesville Ravine Park near the walking trails. Nitrate levels are increasing at the slowest rate at Swede Spring.

The sentinel springs were first monitored in March 1985 with a single sampling event. Increased monitoring activities were outlined in the NCRWMO's watershed management plan leading to monitoring in 2011, 2014, and 2017. Beginning in 2019, Dakota County Parks provided funding for quarterly sampling in order to get a higher resolution dataset to better understand nitrate levels in the watershed over time.
