# North Cannon River WMO

## 2018 Water Monitoring Presentation

Dakota County Soil and Water Conservation District

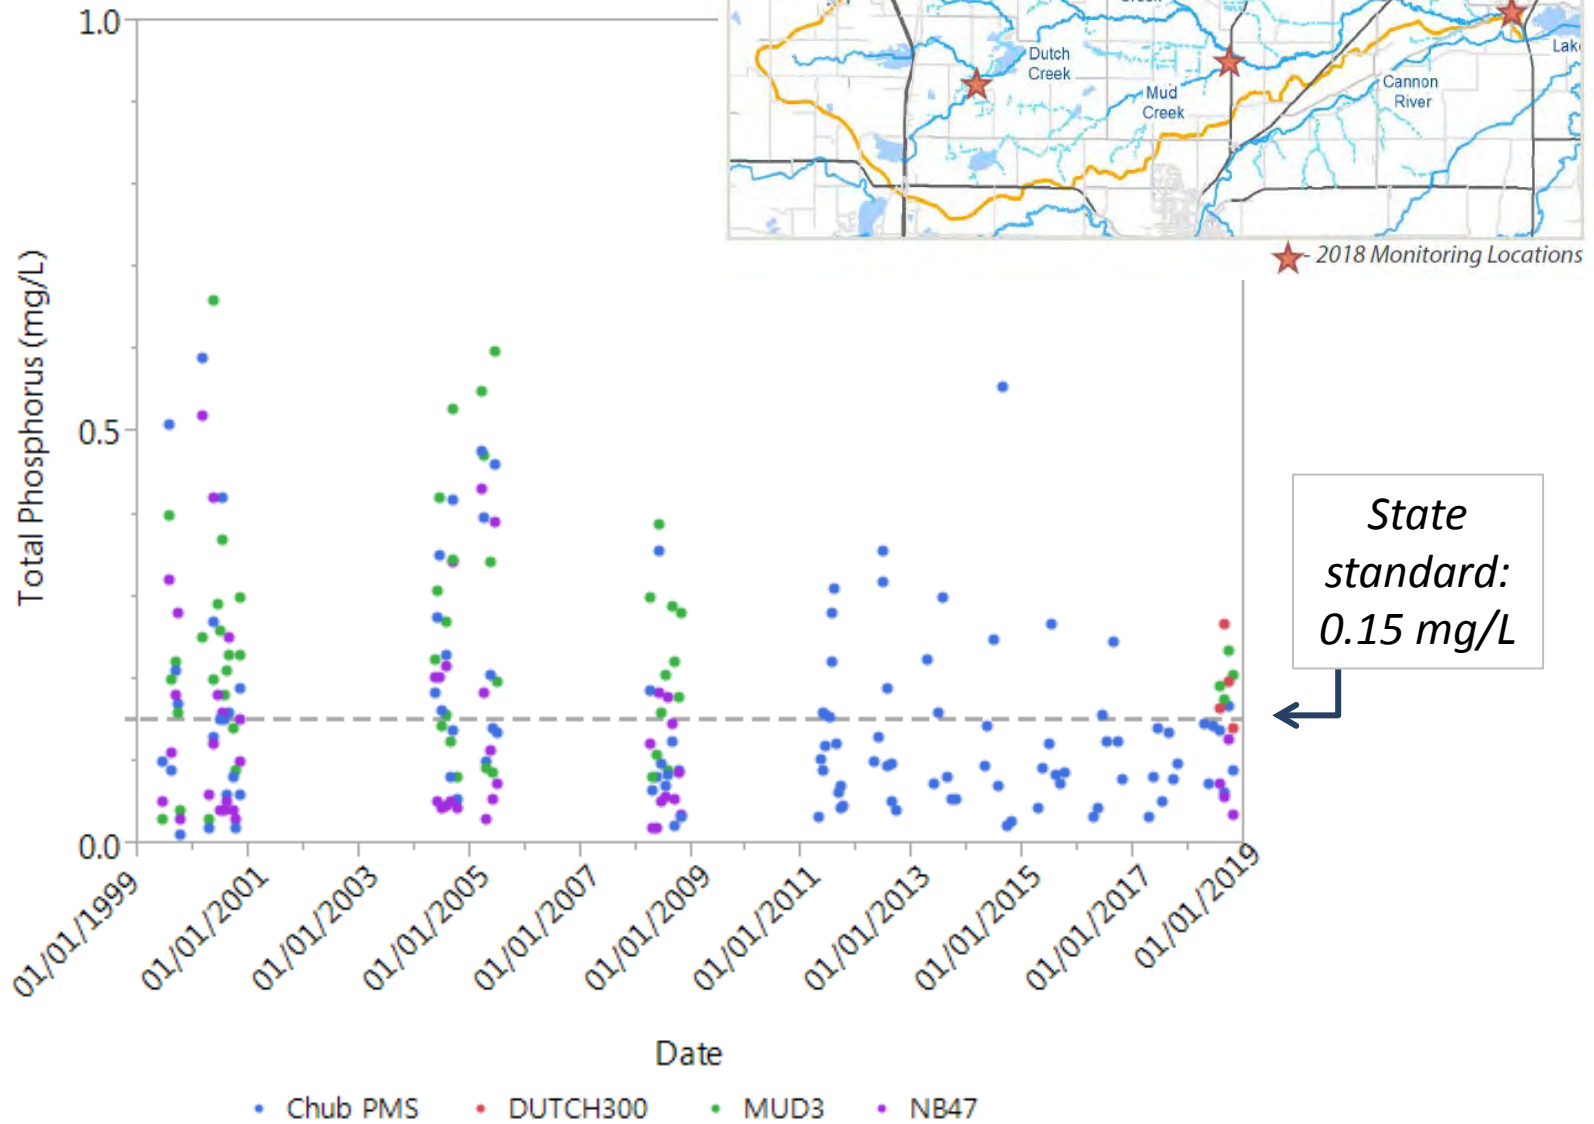
# Total Phosphorus

## Chub Creek

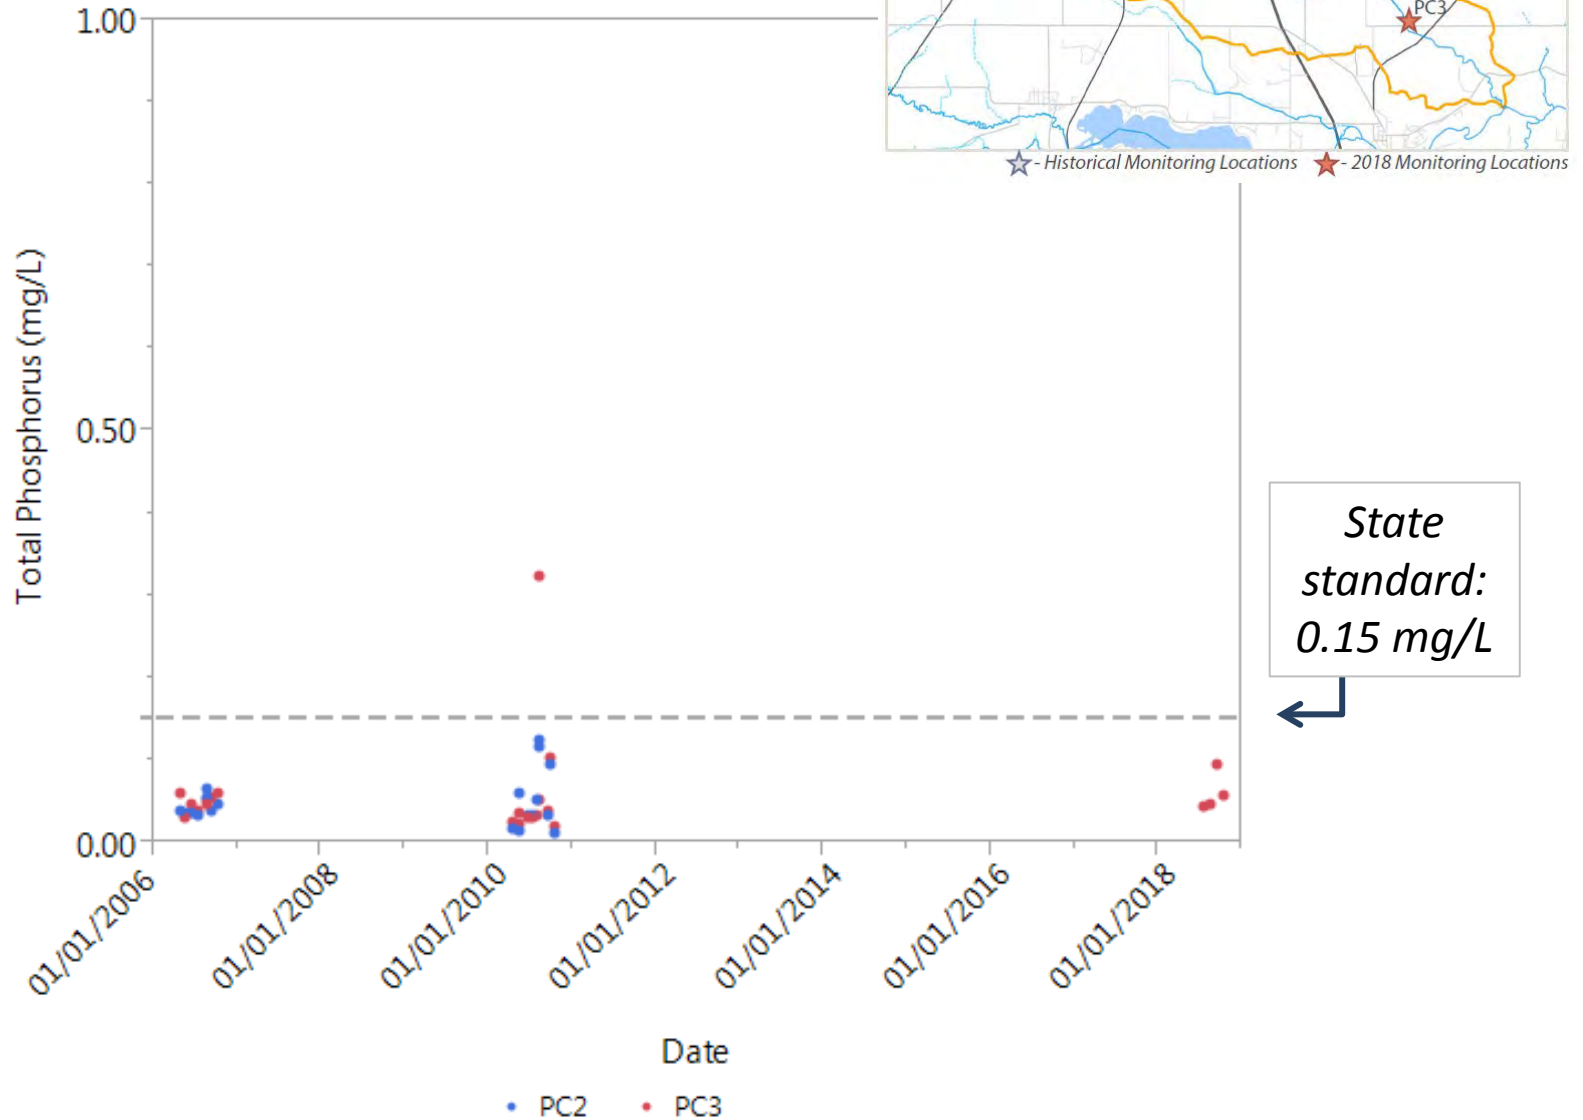
# Total Phosphorus

## Pine Creek

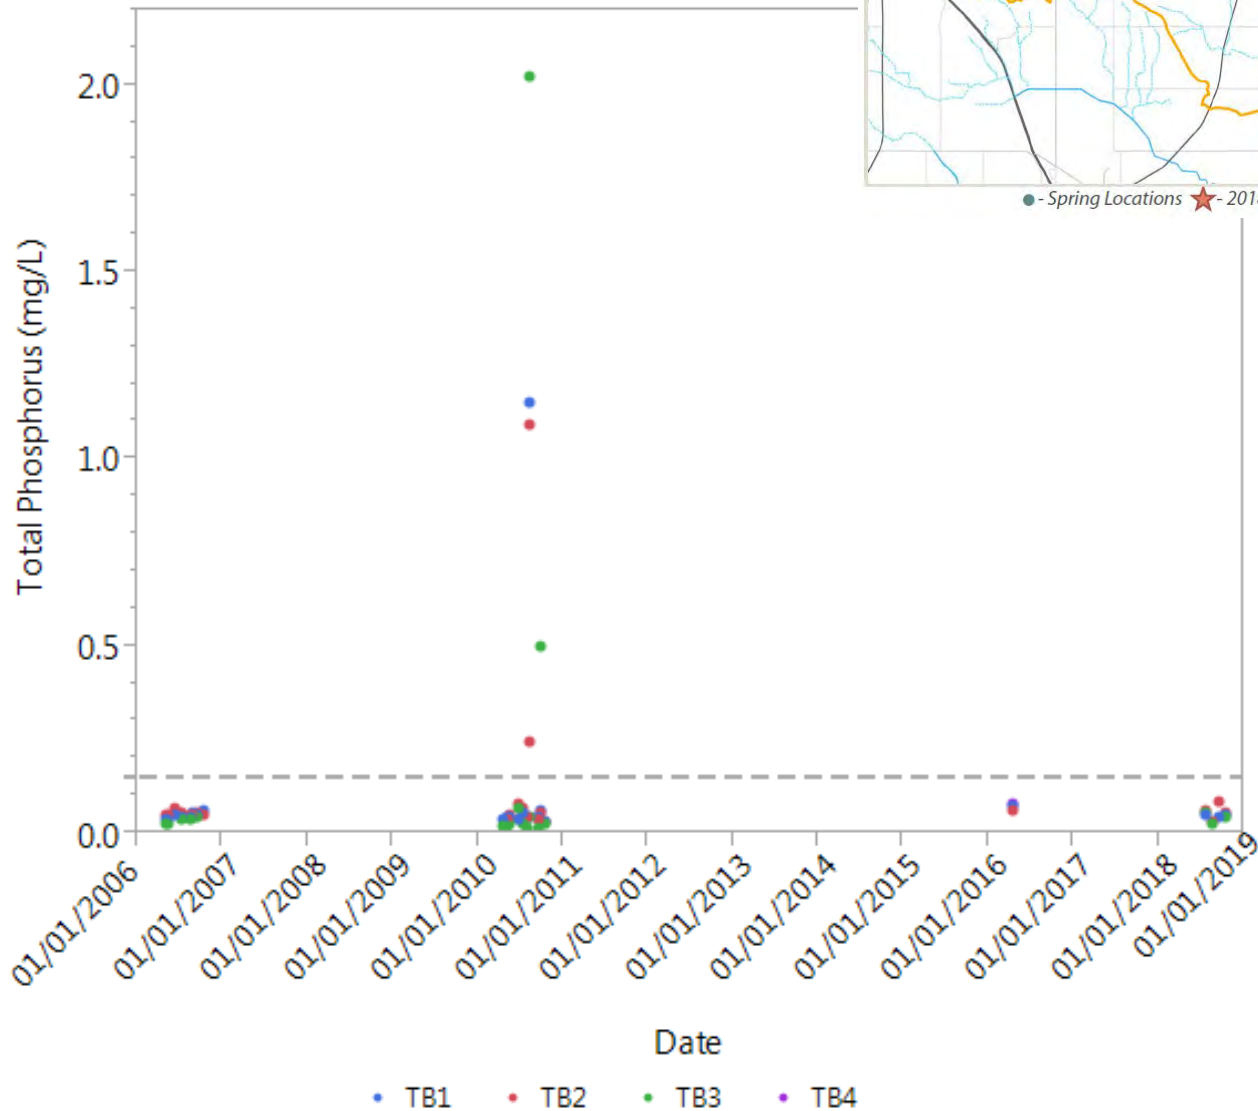
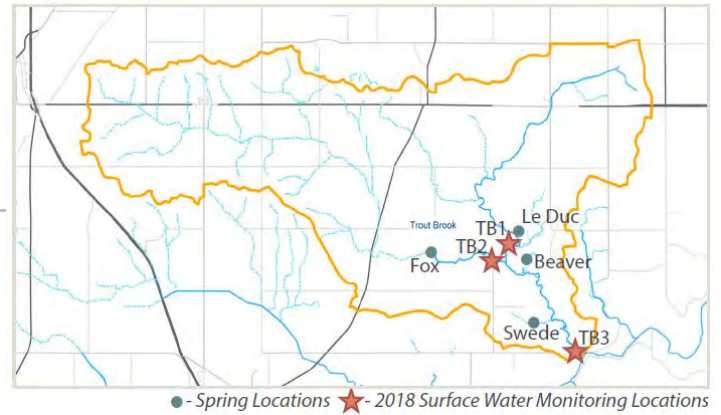
# Total Phosphorus

## Trout Brook

State  
standard:  
0.15 mg/L

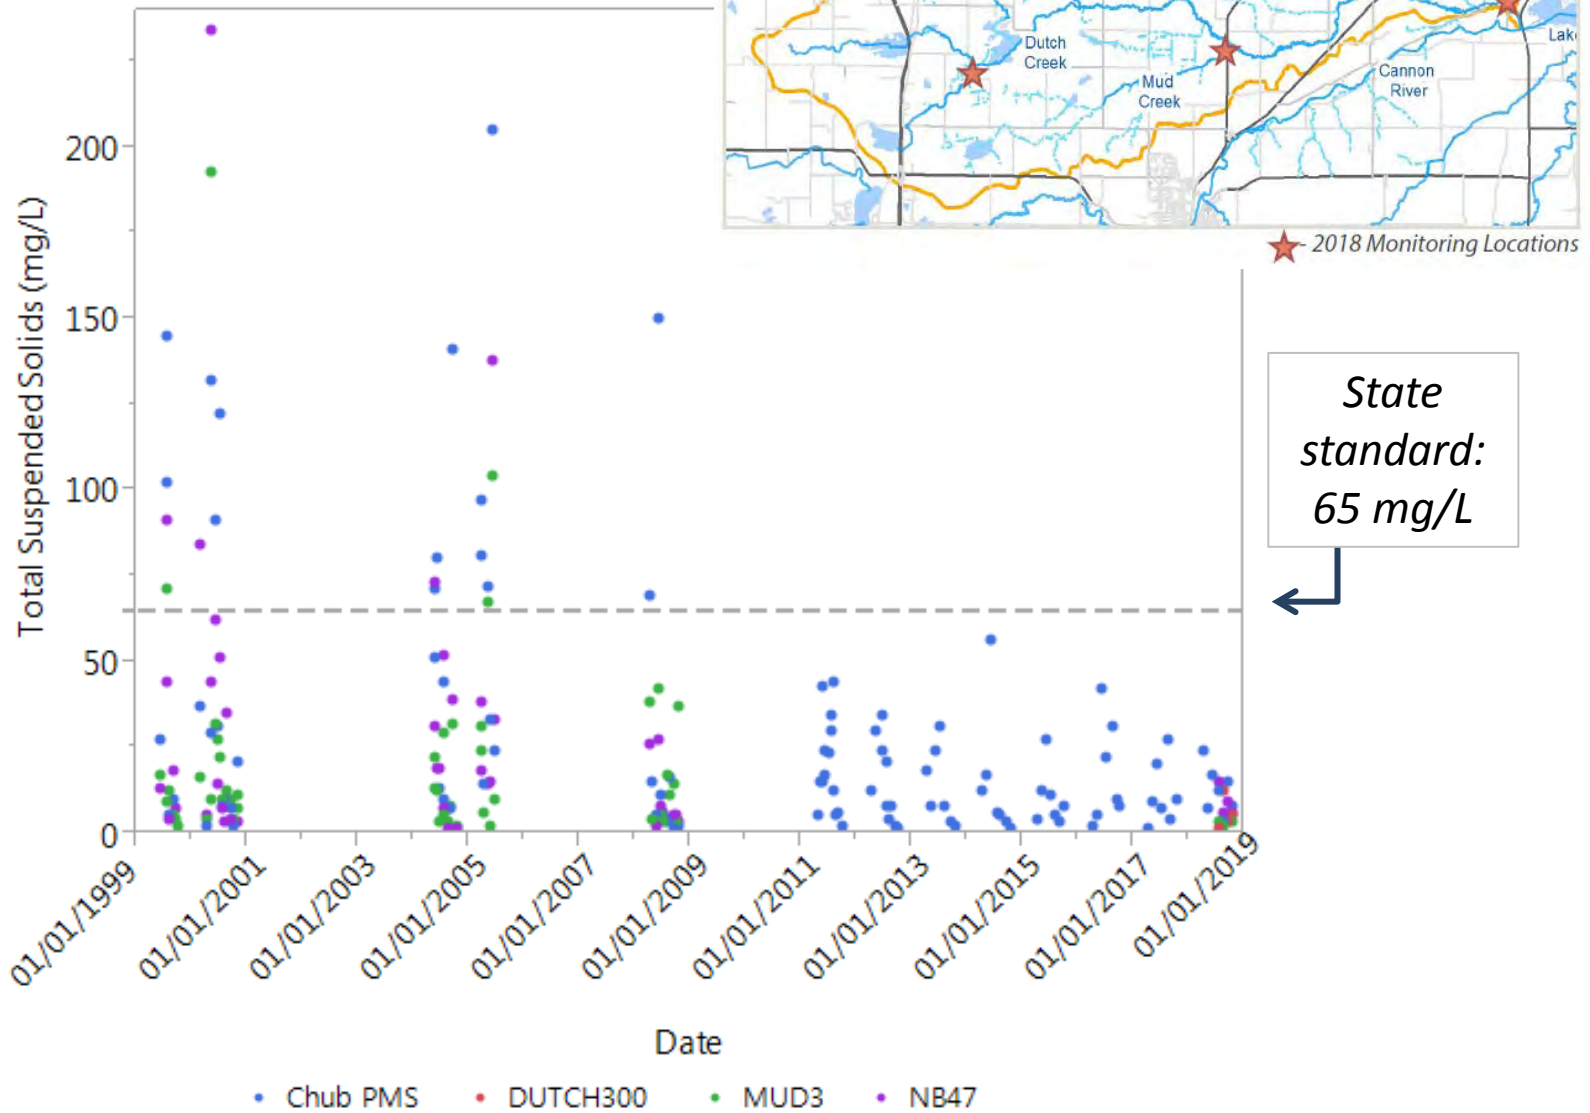
# Total Suspended Solids

## Chub Creek

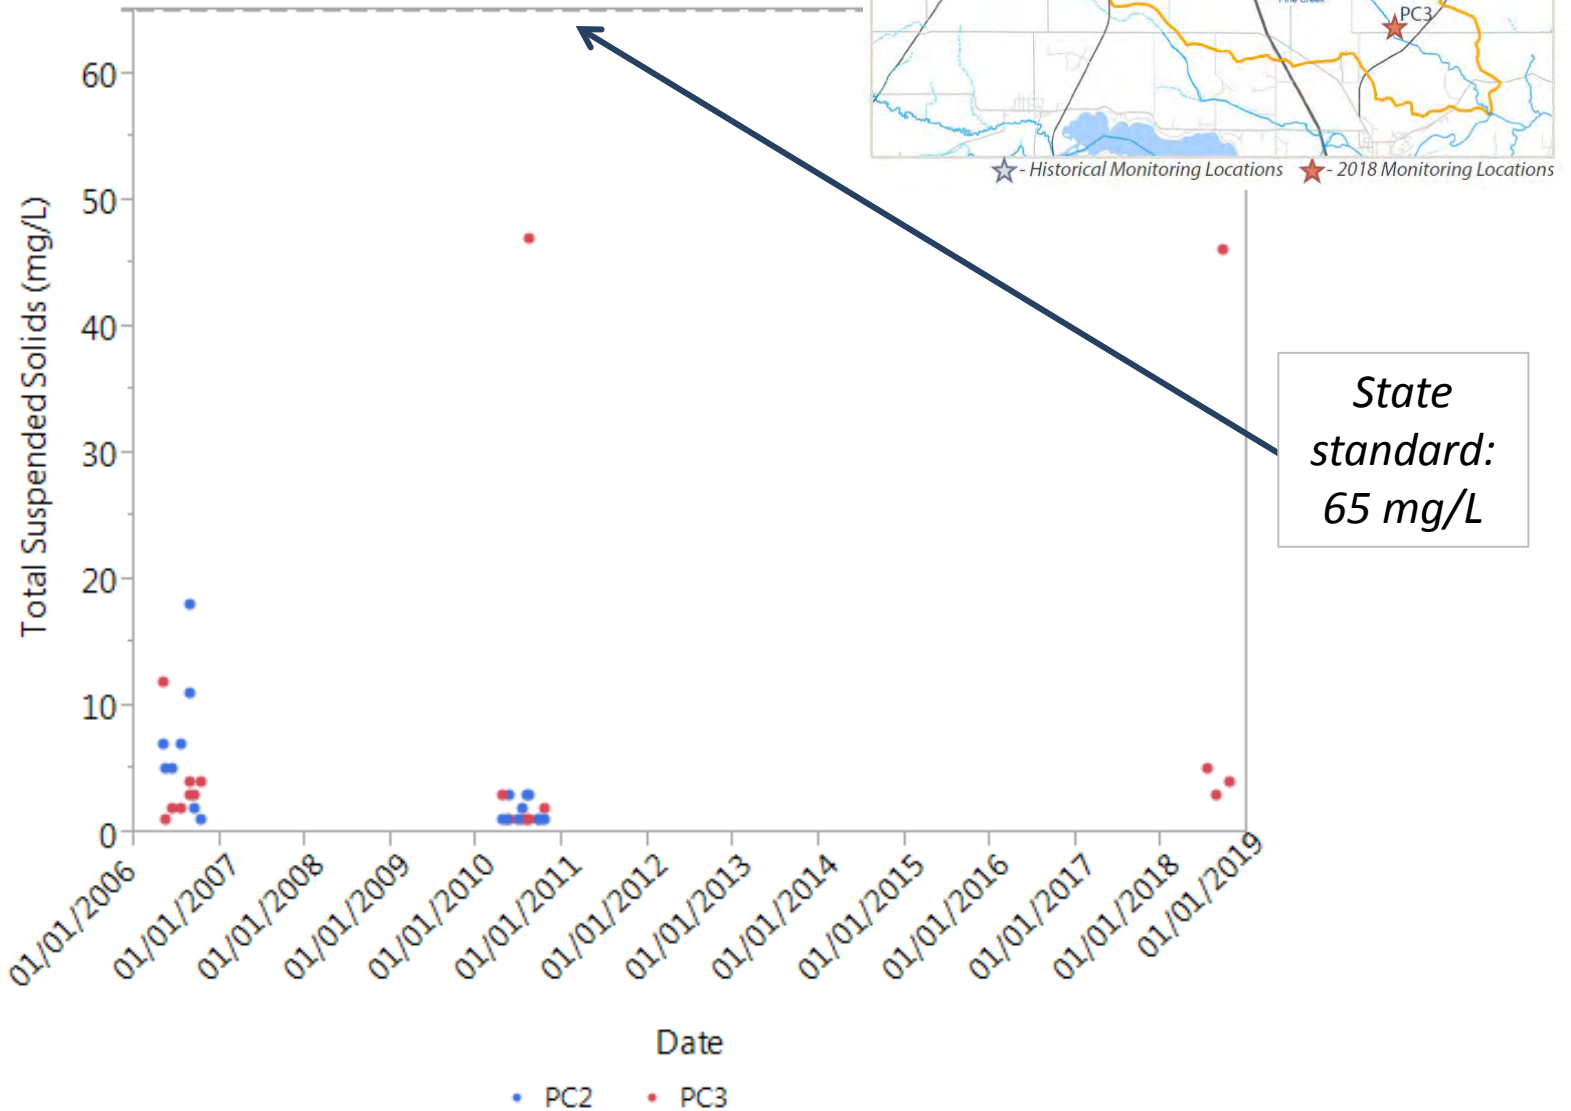
# Total Suspended Solids

## Pine Creek

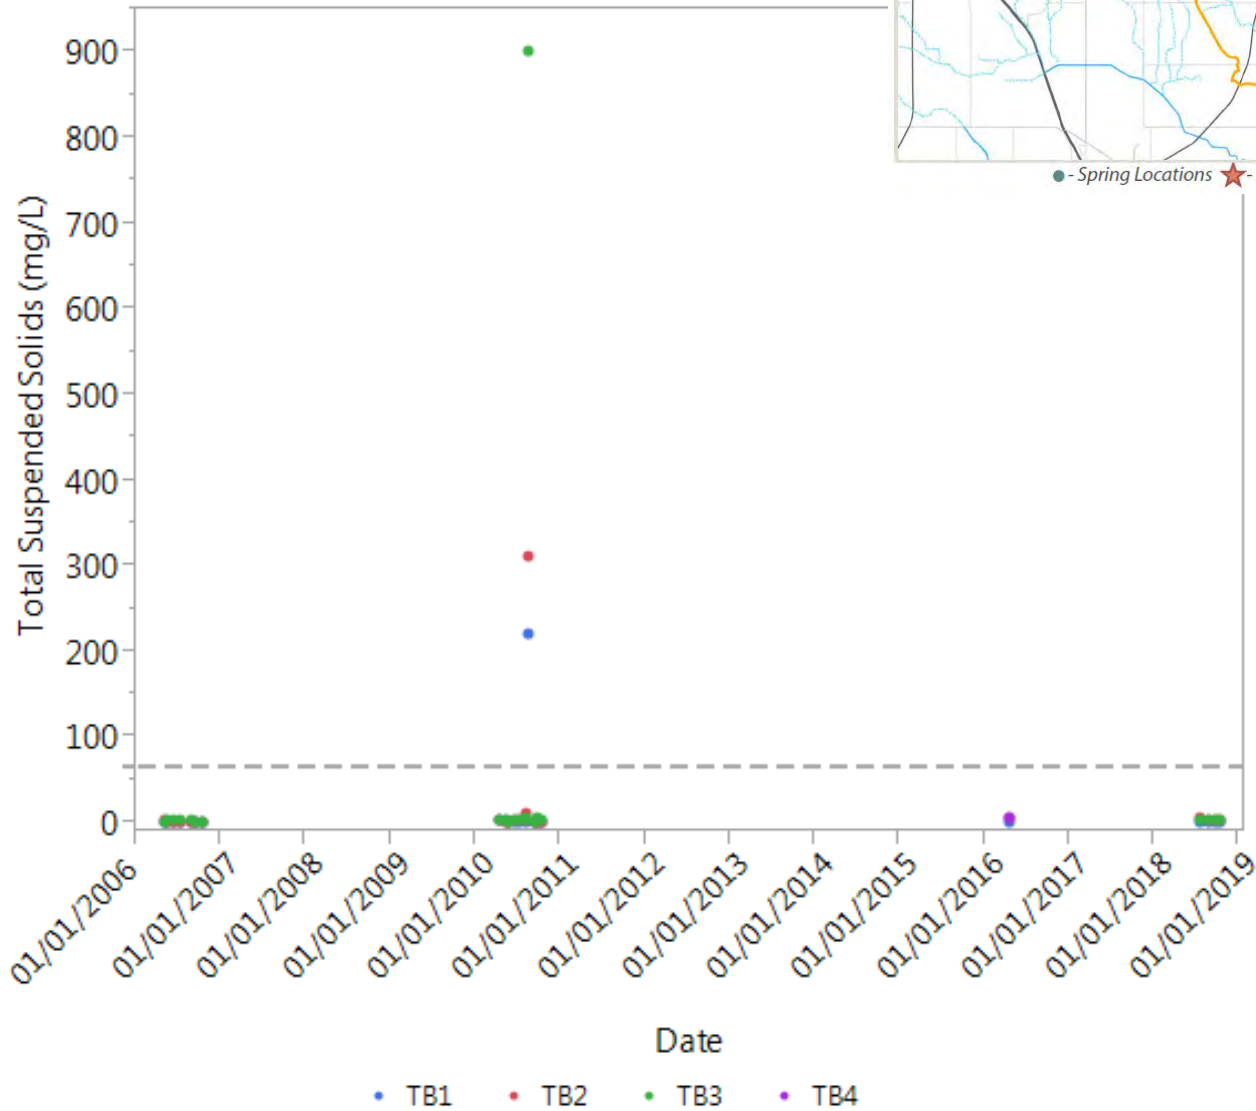
# Total Suspended Solids

## Trout Brook

State  
standard:  
65 mg/L

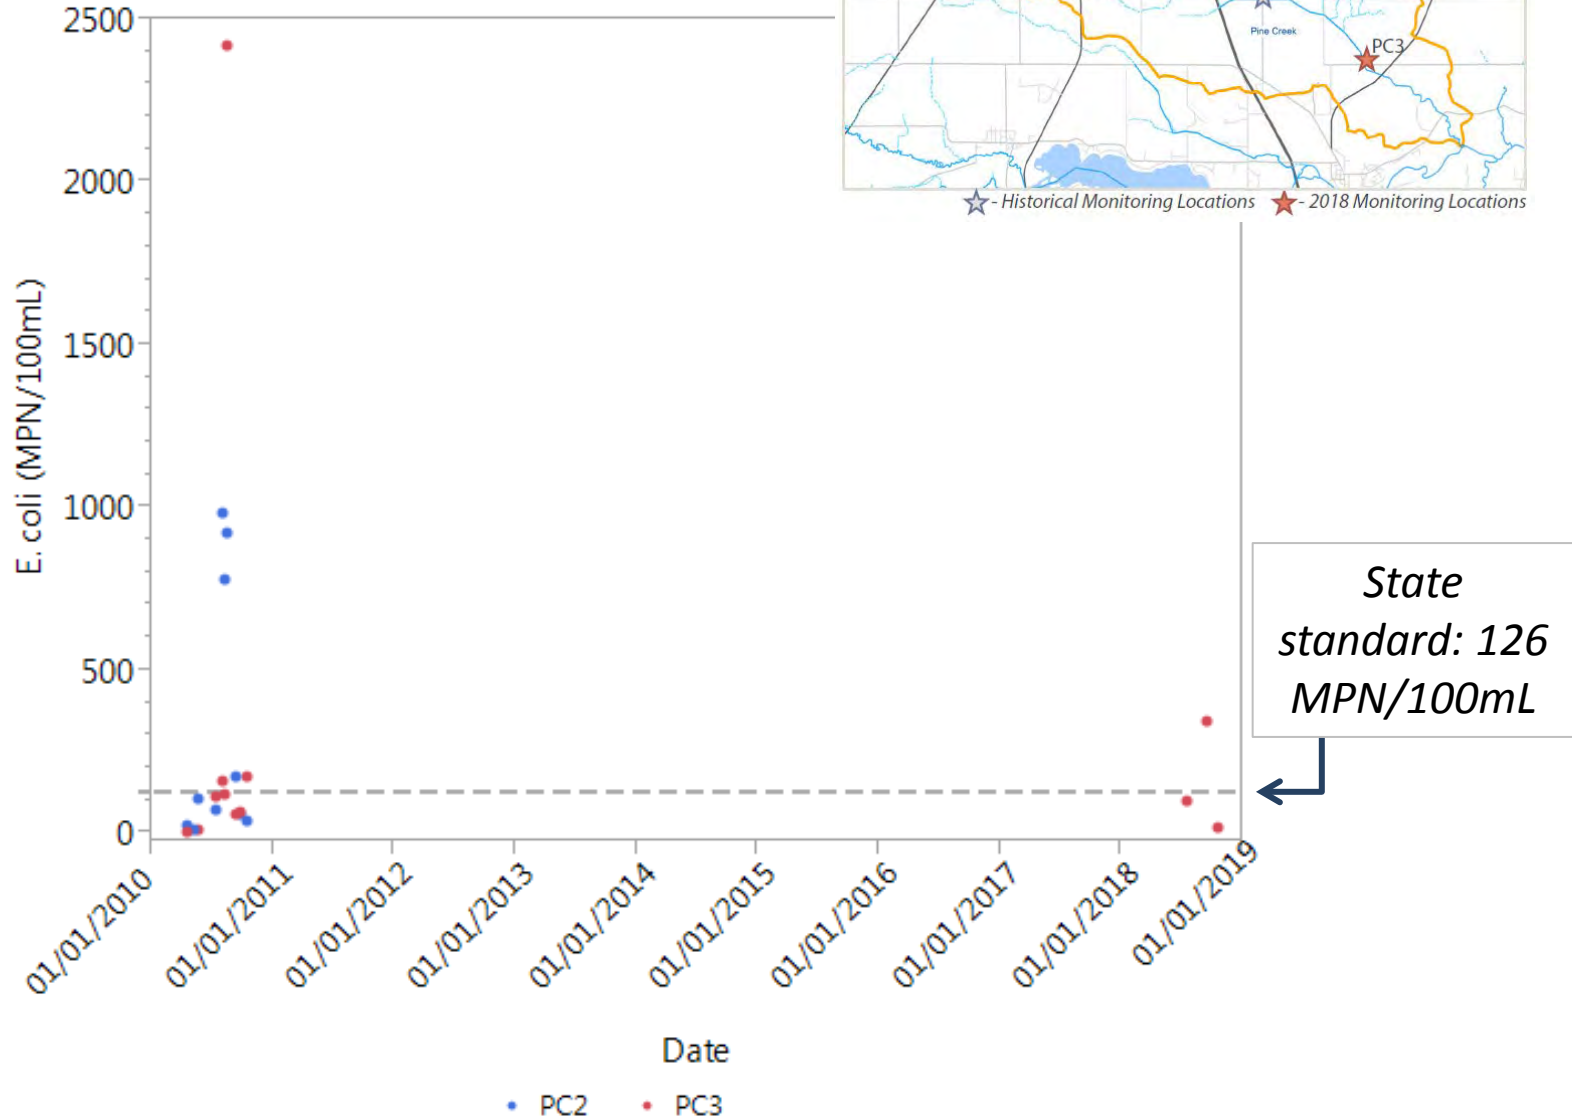
# E. coli Bacteria

## Pine Creek

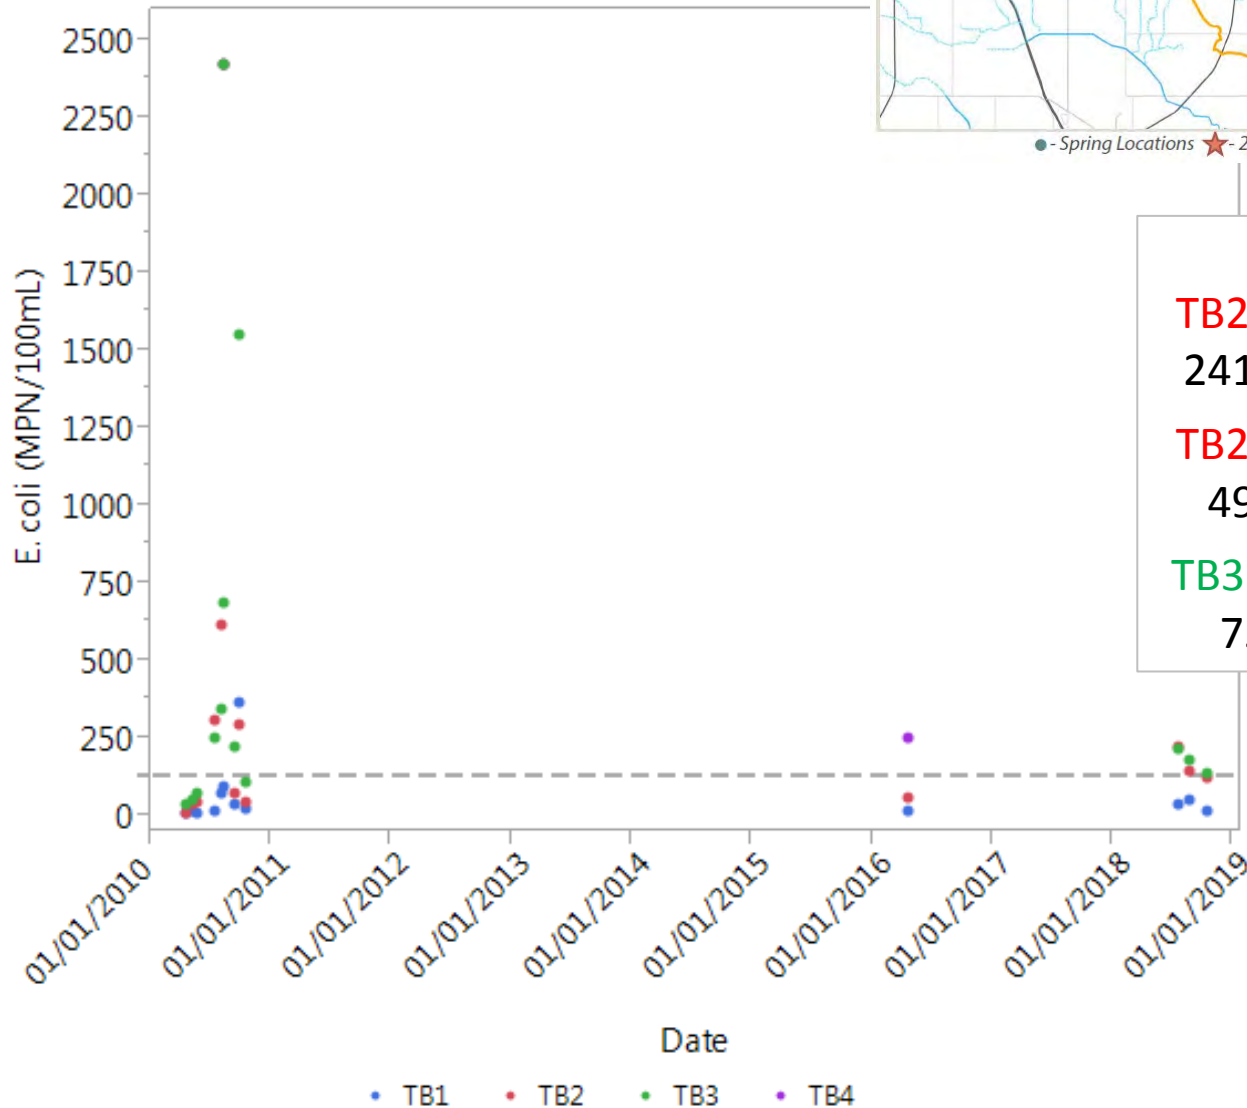
# E. coli Bacteria

## Trout Brook

**Outliers:**  
TB2 on 8/13/10 - 241960 MPN/L  
TB2 on 9/19/18 - 49500 MPN/L  
TB3 on 9/19/18 - 7500 MPN/L

State standard: 126 MPN/100mL

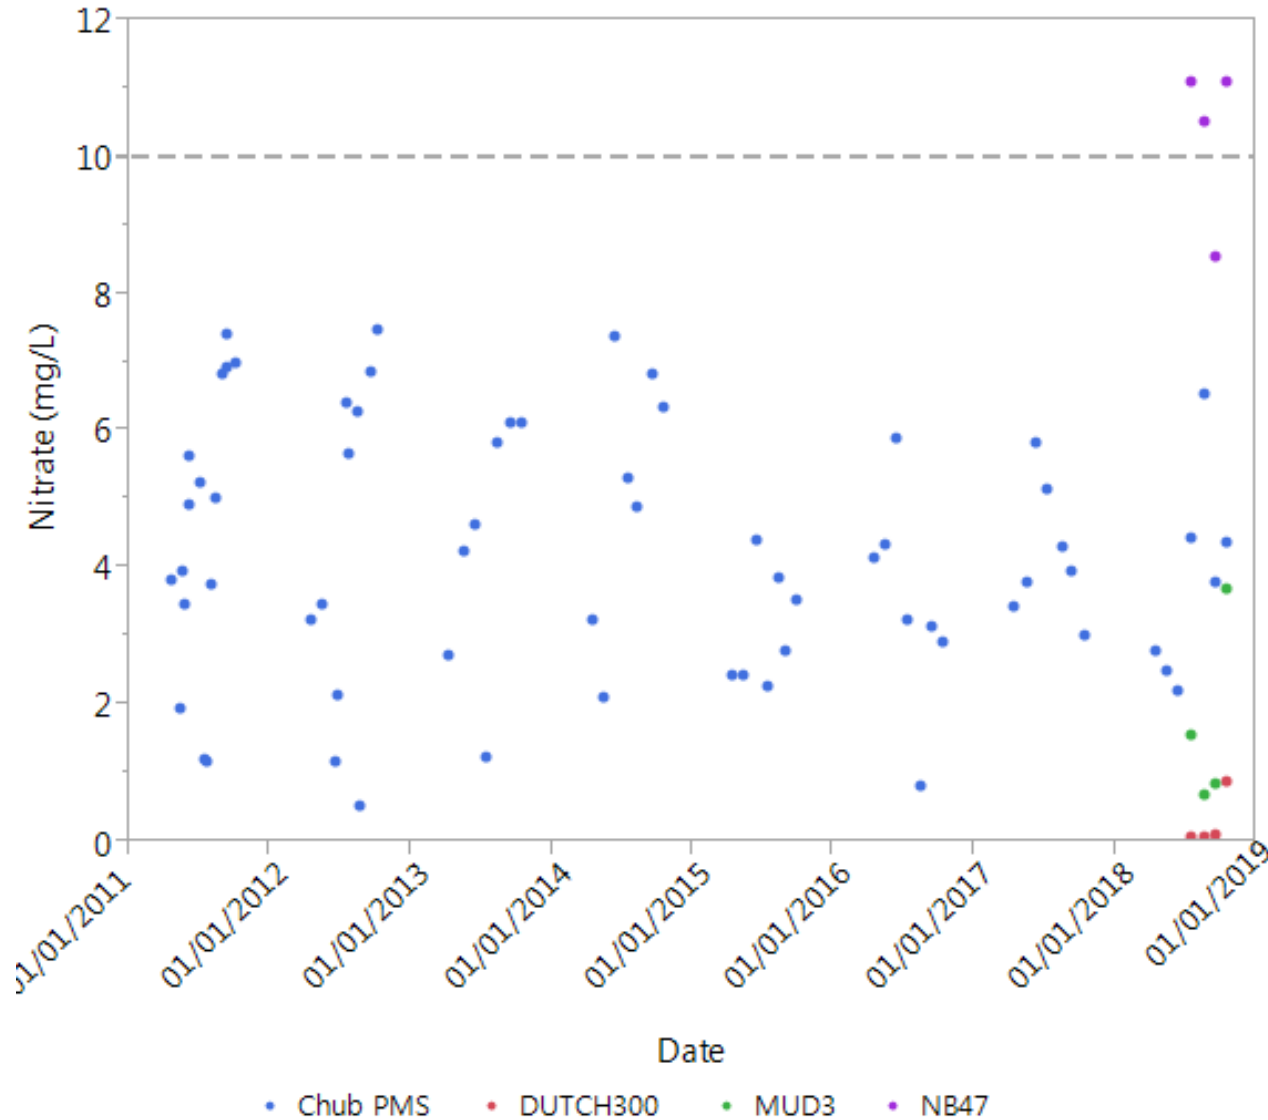
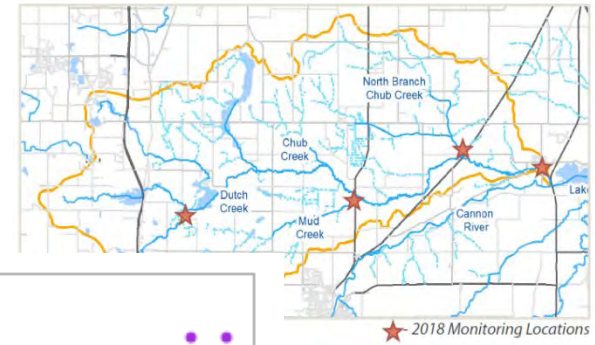
# Nitrate

## Chub Creek

←  
*Drinking  
water  
standard:  
10 mg/L*

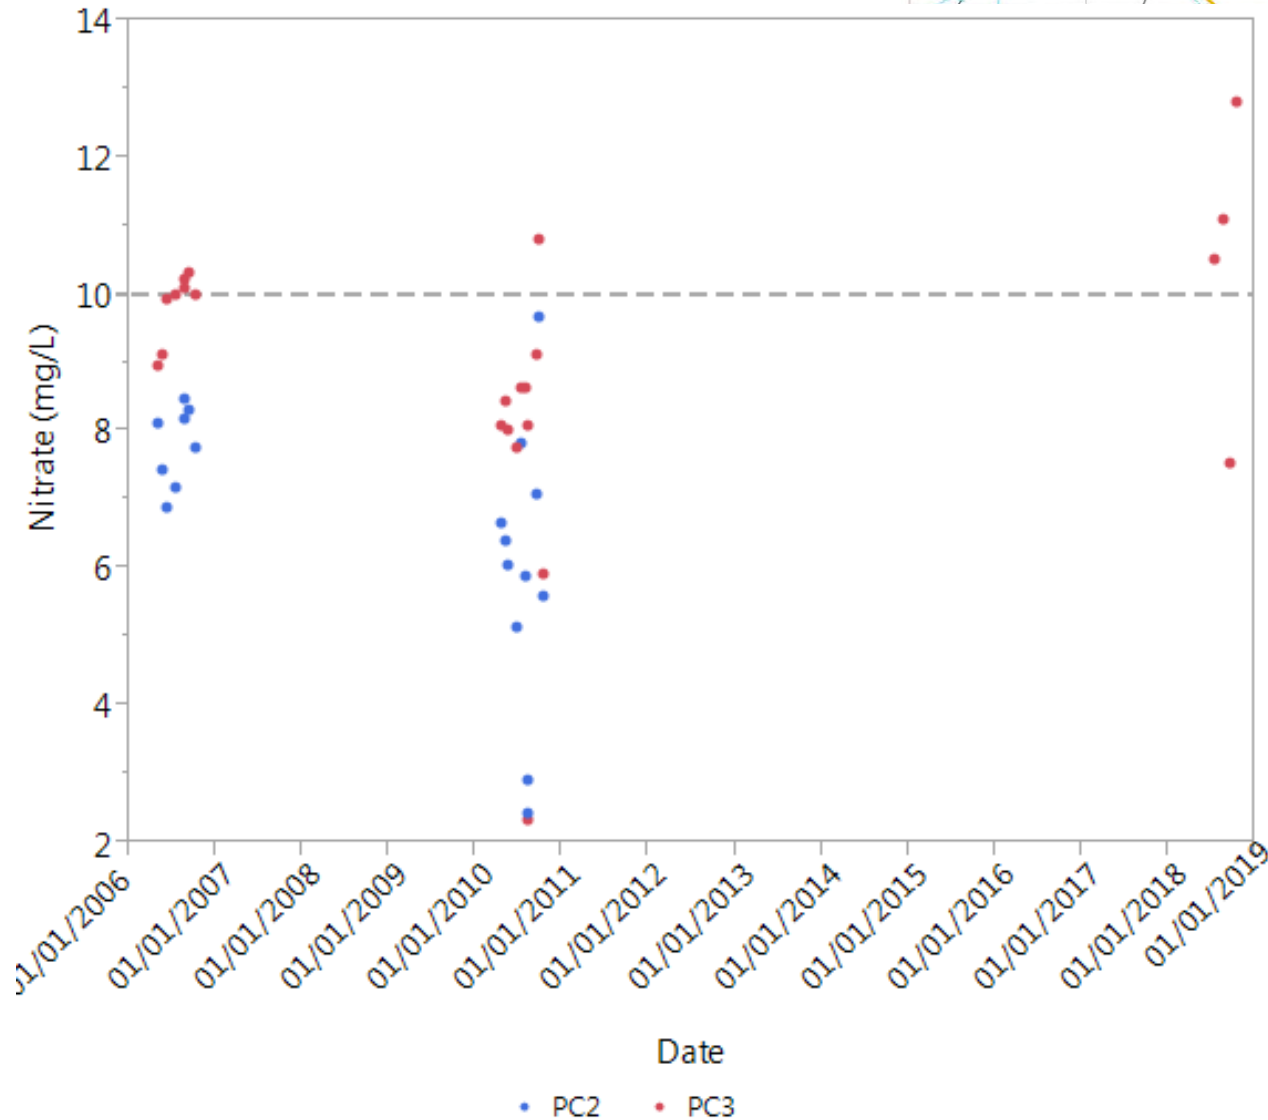
# Nitrate

## Pine Creek

← Drinking water standard: 10 mg/L

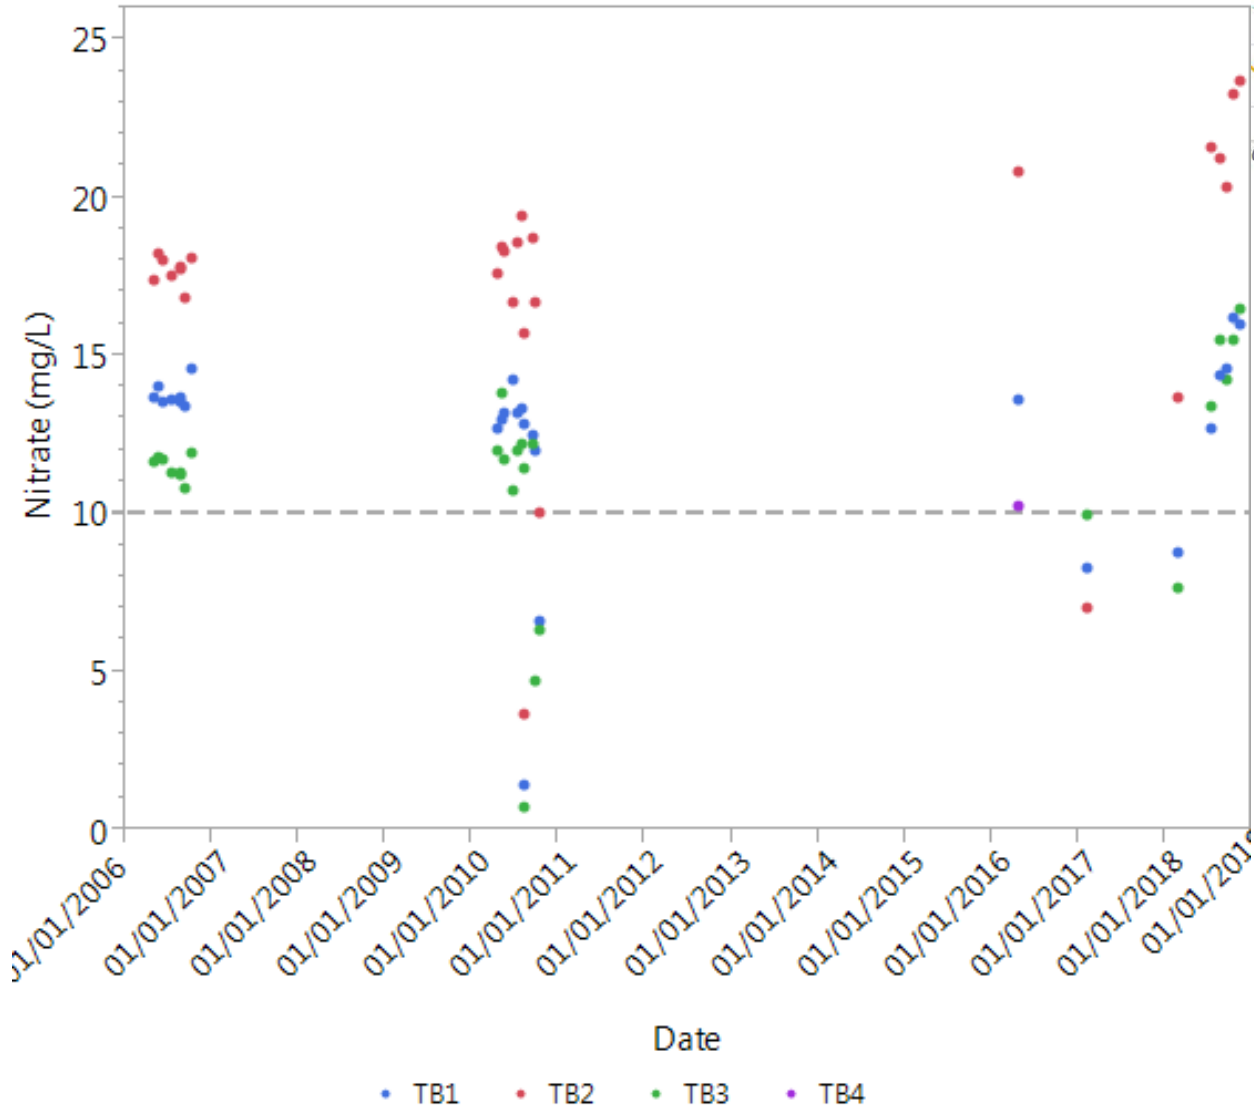
# Nitrate

## Trout Brook

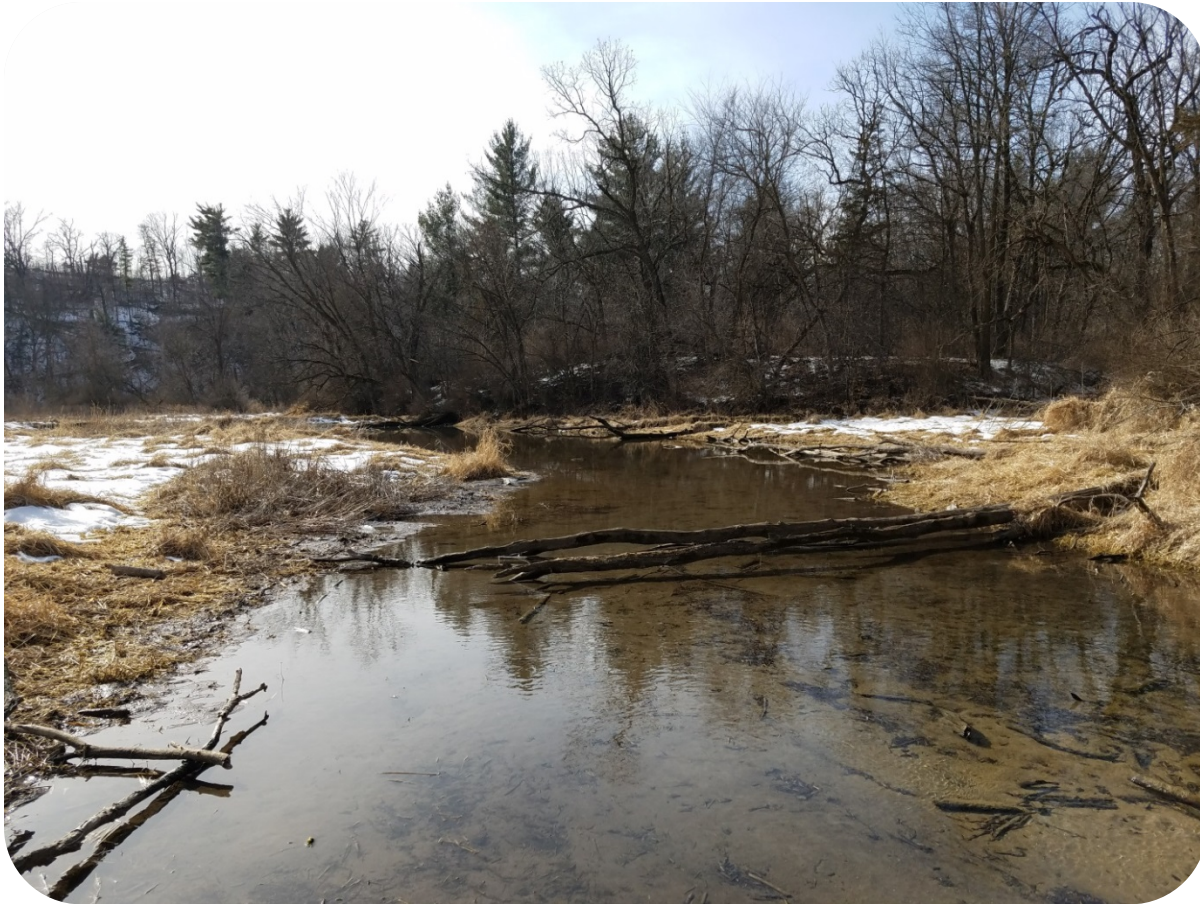
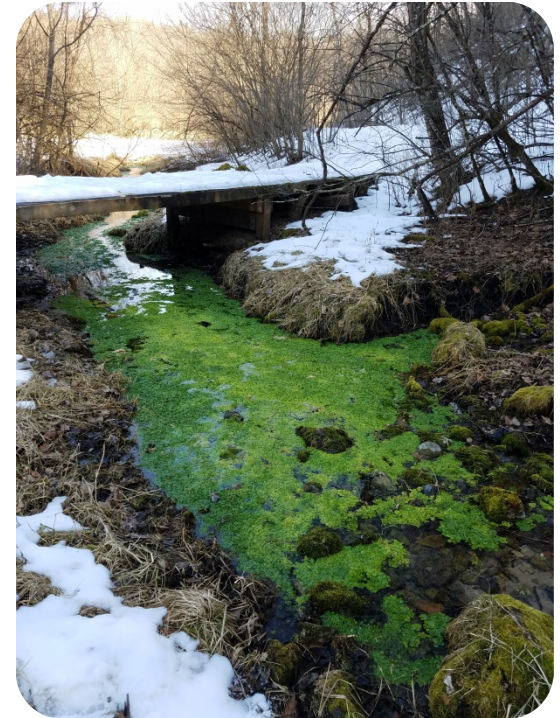
# Trout Brook Nitrate Monitoring

*\*\*Highest stream baseflow  
nitrate concentrations  
found in southeastern  
Minnesota*

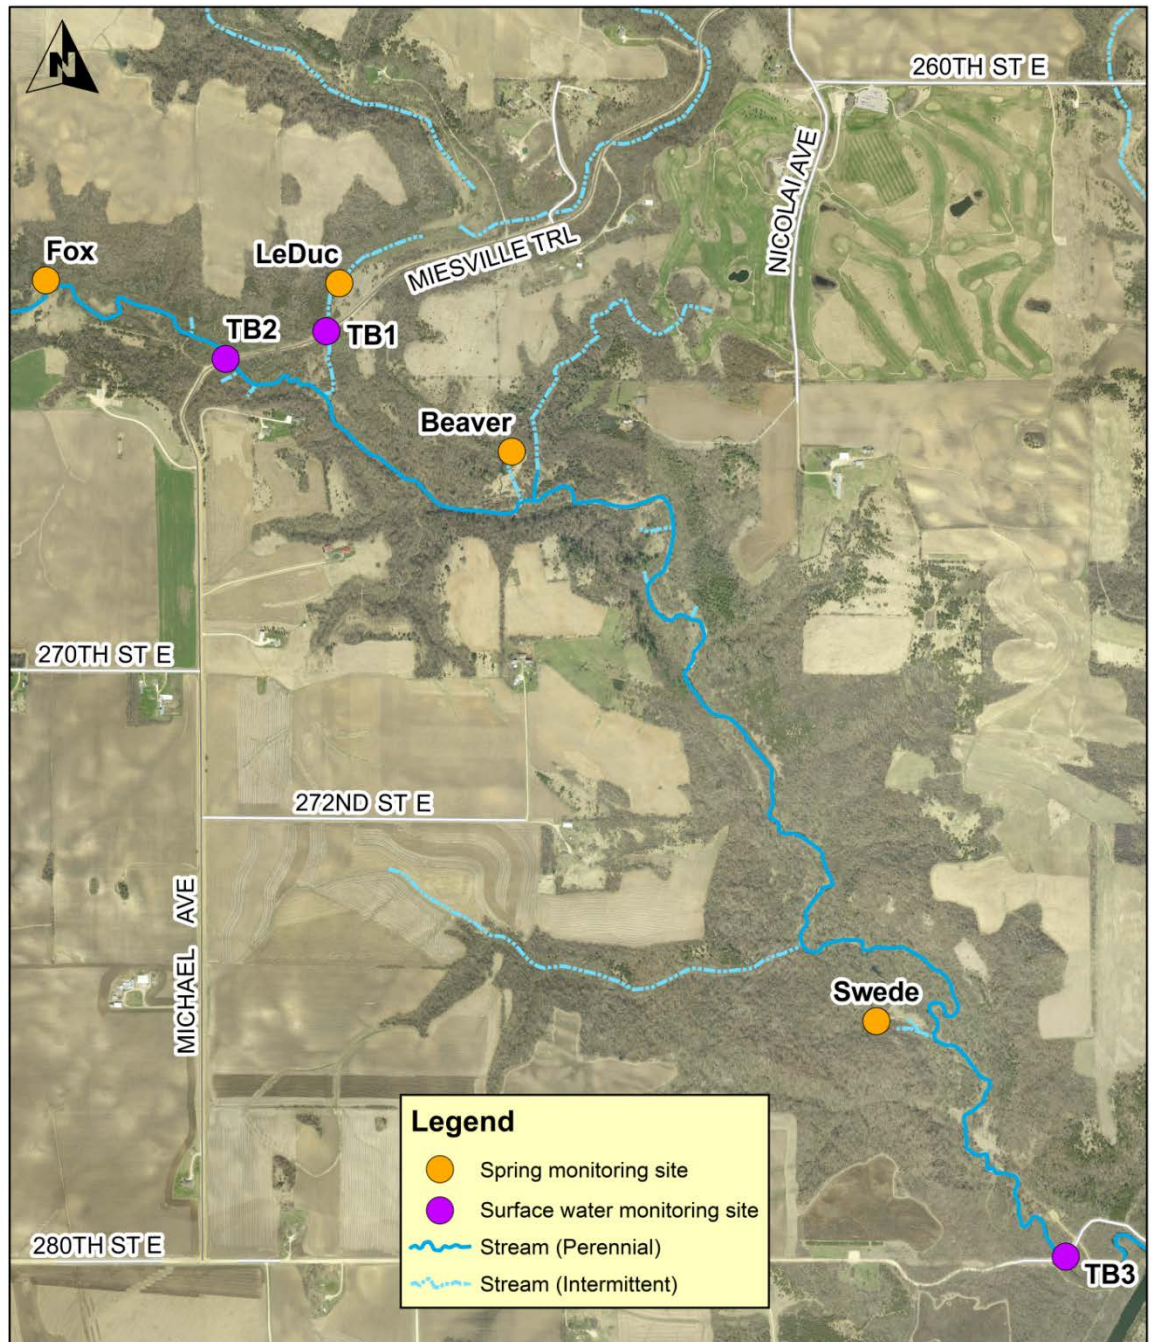
# Monitoring Sites

## Three stream

- TB1
  - East branch
- TB2
  - West branch
- TB3
  - Watershed outlet

~ 15 year data record
