Watershed Management Organization

North Cannon River Watershed 2020 Water Monitoring Report

Report prepared on behalf of the North Cannon River Watershed Management Organization and Dakota County Parks Department by the Dakota County Soil and Water Conservation District

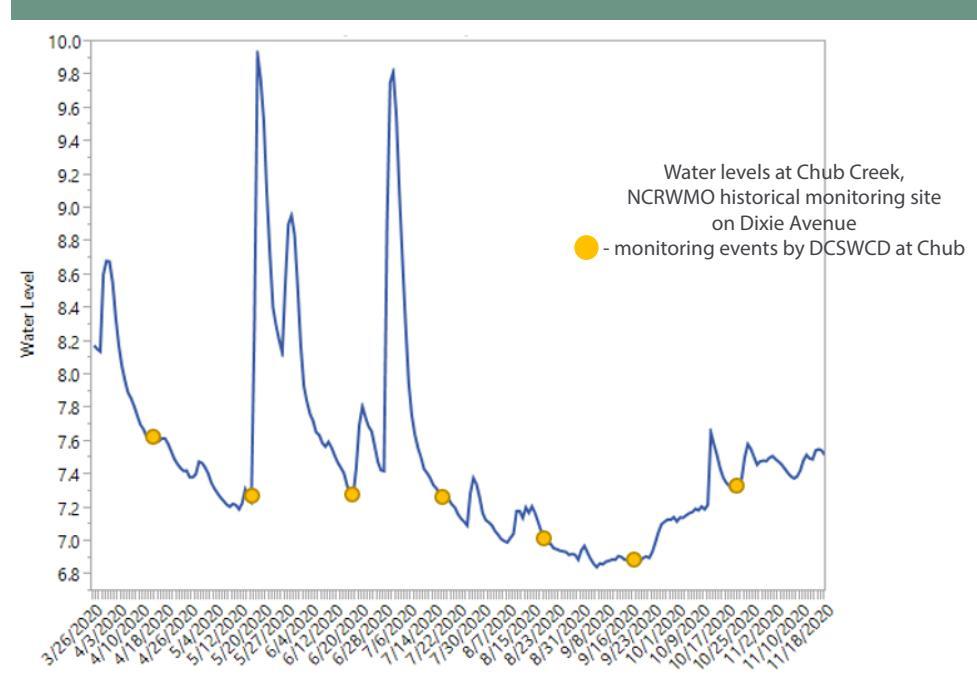
Data collected in 2020 show:

- North Branch Chub Creek has the highest *nitrate* level in watershed (above state standard). Chub Creek has the second highest level, caused by North Branch feeding into Chub Creek above the Chub monitoring site.
- *Total phosphorus* levels in Dutch Creek was highest; both Mud Creek and Chub Chub saw a spike in July (Chub spike caused by Mud).
- *Total suspended solids* and *chlorophyll-a* (new in 2020) had high variability throughout the monitoring season.
- *E. coli* levels at all sites exceeded the state standard during most monitoring events. Dutch Creek (tailend of a wetland complex), Chub Creek, and Mud Creek had the highest levels.

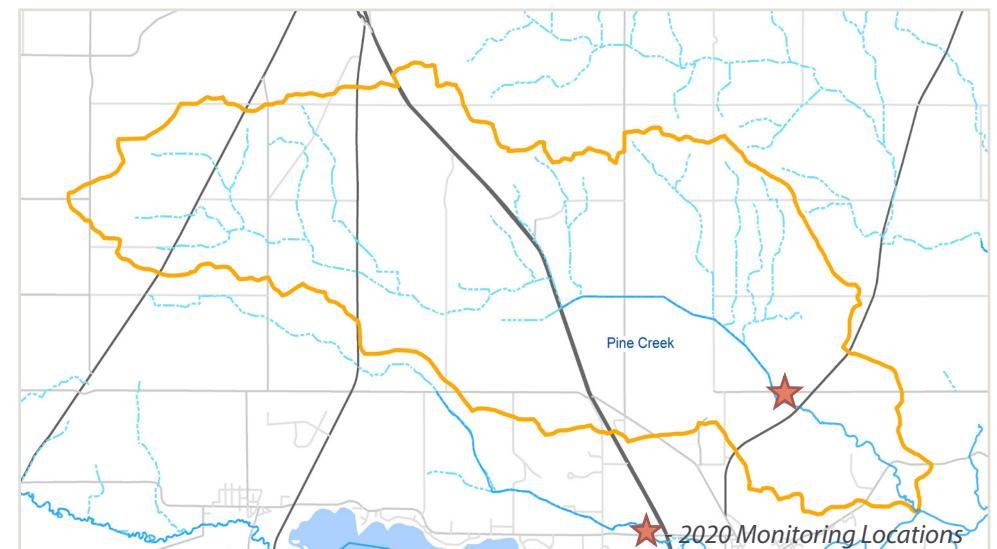
Data collected in 2020 show:

- Phosphorus and sediment levels
 were consistent all season
 and stayed below the state
 standard
- E. coli level were below the state standard in both the spring and fall months, but increased during the summer months
- Nitrate level averaged just under 12 mg/L; exceeding the drinking water standard throughout the seaons

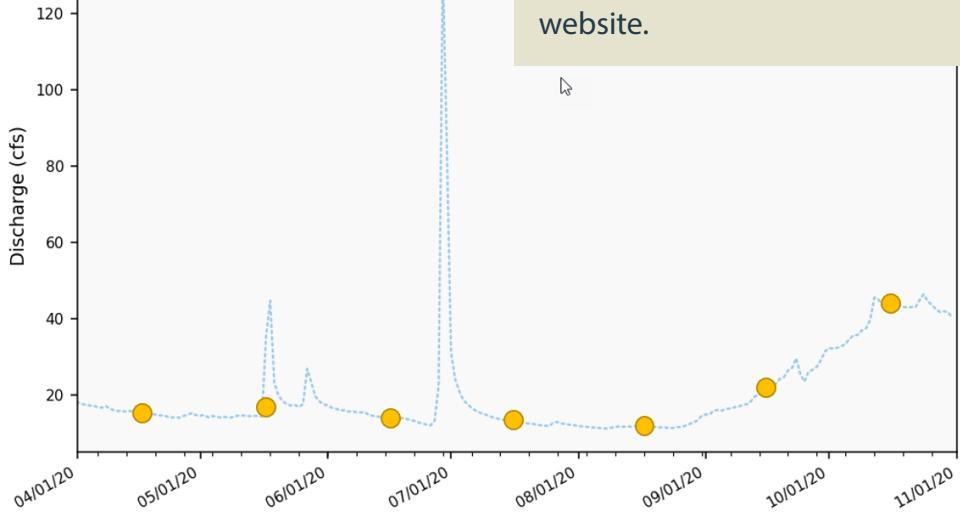
Discharge (cubic feet per second) at PC2, NCRWMO historical monitoring site on Hogan Avenue - monitoring events by DCSWCD at PC3

MNDNR hydrologists visit this site and another site upstream intermittently to monitor streamflow from March to November each year. Continuous temperature and water level monitoring equipment are deployed at both monitoring sites year round and data is collected on 15 minute intervals. Data is available on the MNDNR's website.

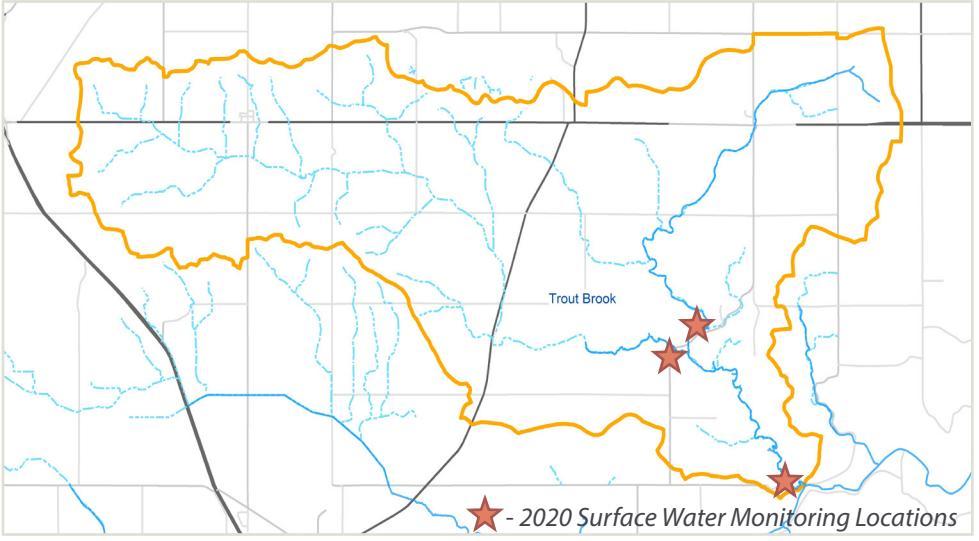
Surface and groundwater monitoring acitivites occur in and around Trout Brook. Three surface water sites are monitored during the field season, testing water from the tributary and mainstem upstream of their confluence, as well as at the bottom of the watershed.

TB2: Highest *nitrate* level in watershed (influenced by Fox Spring). *Phosphorus* and *sediment* remain low. *E. coli* saw a late season spike in August (unlike other two sites in watershed.) **TB1:** *Nitrate* level exceeds state standard throughout the season. *Phosphorus* levels are highest in the watershed, but *sediment* remains low. *E. coli* spike in early summer, but stayed below the state standard beginning in August

TB3: Lowest *nitrate* level of all three sites (possibly influenced by groundwater influx). *Phosphorus* remained low all season. *Sediment* spiked in early spring following runoff event. *E. coli* spiked in June (level in line with TB1 spike in May).

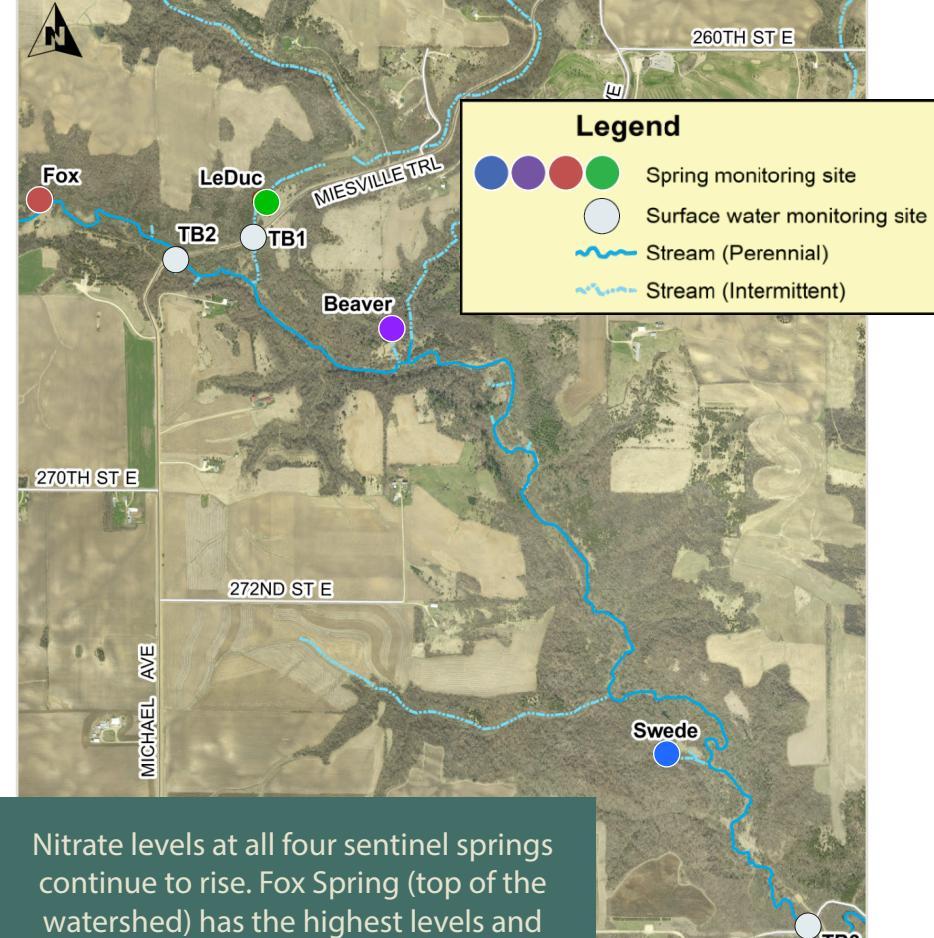
watershed) has the highest levels and Swede Spring (bottom of the watershed) has the lowest nitrate levels. All sites have nitrate levels above the state standard.

Sentinel Springs Beaver, Fox, Le Duc, Swede

Sampling frequency increased to quarterly in order to get a higher resolution dataset to better understand nitrate levels in the watershed over time.

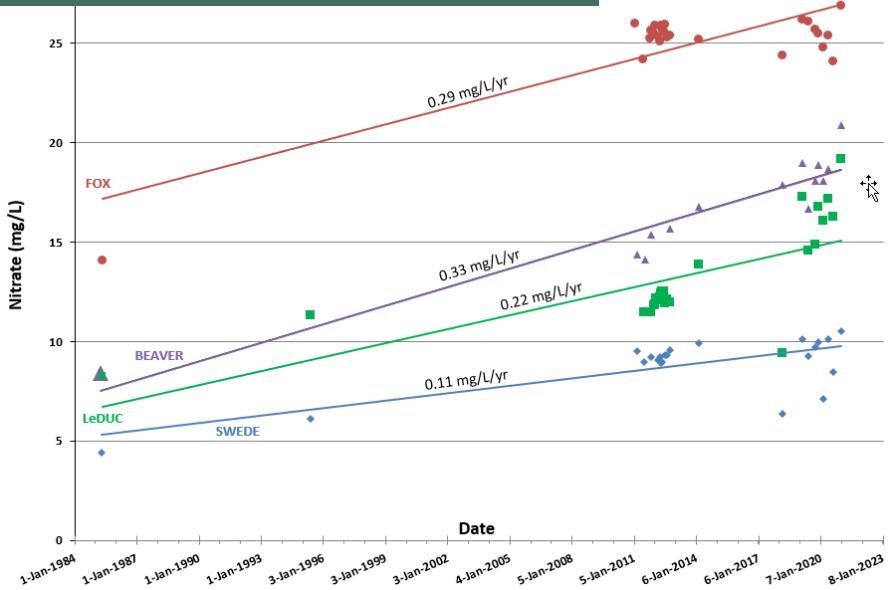
Samples collected during baseflow conditions
