2023 Water Monitoring Report

WATERSHED MANAGEMENT ORGANIZATION

Report prepared on behalf of the North Cannon River Watershed Management Organization and Dakota County Parks Department by the Dakota County Soil and Water Conservation District

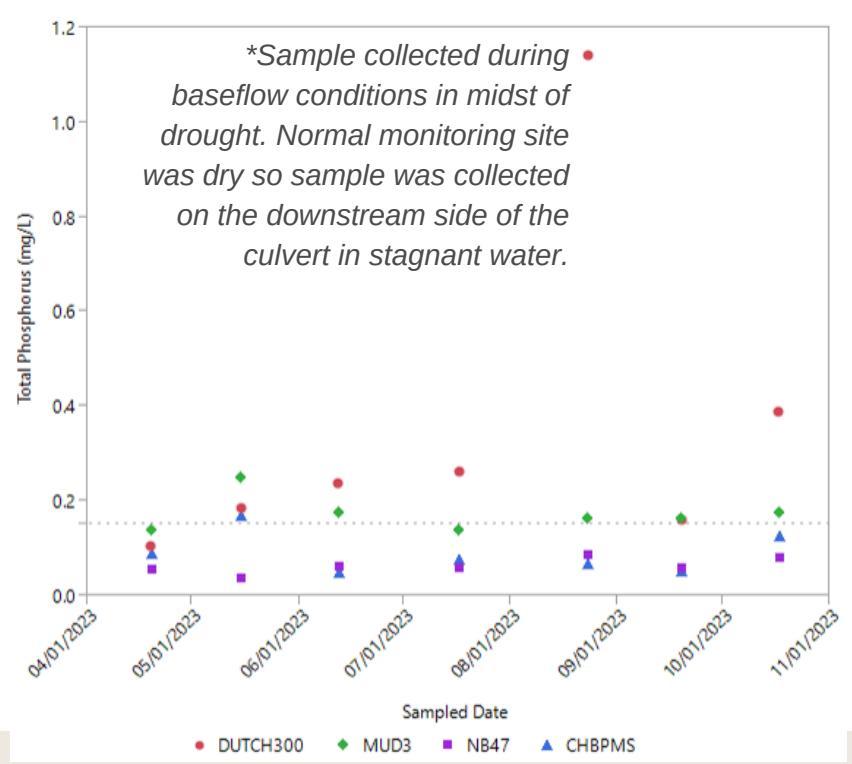
Total Phosphorus (TP) includes all forms of phosphorus; particulate and dissolved. The **state standard of 0.15 mg/L** (grey dotted line on graph to right) was **exceeded several times at the sites on Dutch and Mud Creeks**. **No exceedances were recorded at the North Branch monitoring site and the mainstem Chub site only had one exceedance** during the field season. Phosphorus levels increased throughout the season at Dutch Creek, whereas the other sites had a higher degree of variability and stayed below or close to the state standard during all monitoring events.

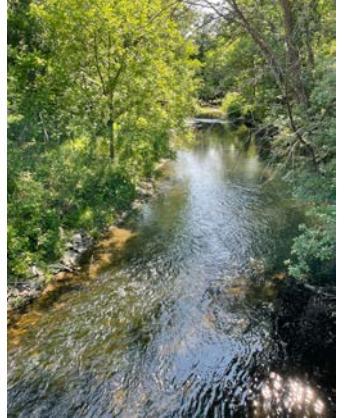
E. coli levels throughout the watershed were lowest in the spring and fall. It is believed that the cold water experienced during these months is likely to contribute to stunting the population growth of the bacteria. Throughout the season, **only seven of 21 samples collected were within the state standard of** \leq **126 organisms/100mL**. The highest measured value occurred in July - 1,733 organisms/100mL, almost 14 times higher than the state standard - at the monitoring site on Chub Creek, the most downstream site in the watershed.

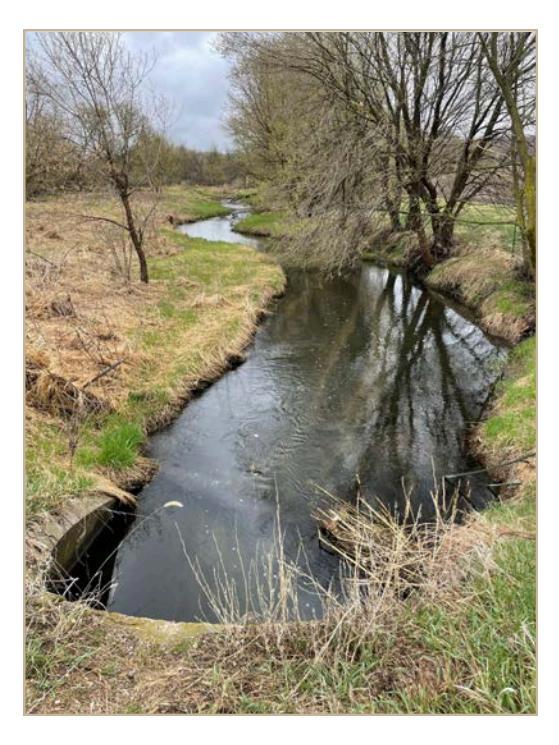
Nitrate concentrations in Pine Creek exceeded the federal standard in all months, but May and June. Nitrate levels have been consistently high since monitoring began in 2006, consistently exceeding the standard throughout the monitoring season. Some variation does occur, but low levels are rare and most likely related to rain events.
